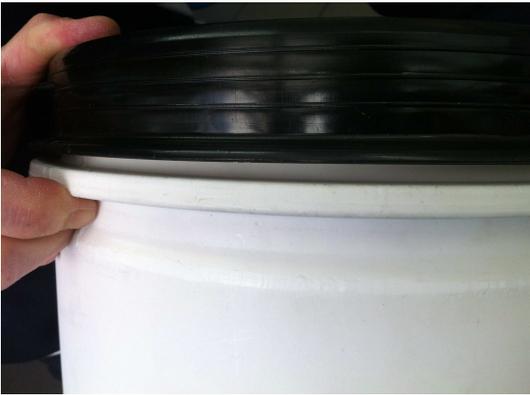
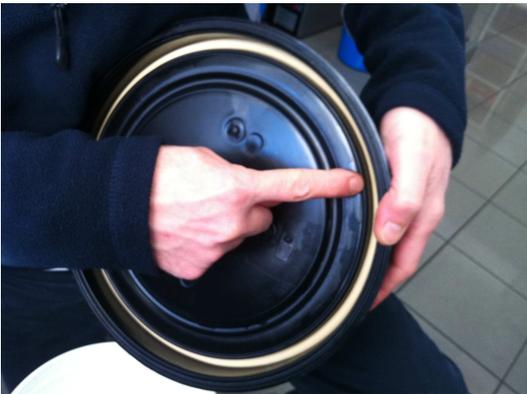
Box has got an internal oversized gasket that doesn't allow the cap to fit properly:

You can remove the gasket from the cap so that the cap fits correctly on the box and it allows the ring to close efficiently. The water tightness of the box is not compromised by taking the gasket off!
